Figure 1. Vertical Exhaust Stacks on the Rear deck of the Forever Resort's Houseboat rental fleet.

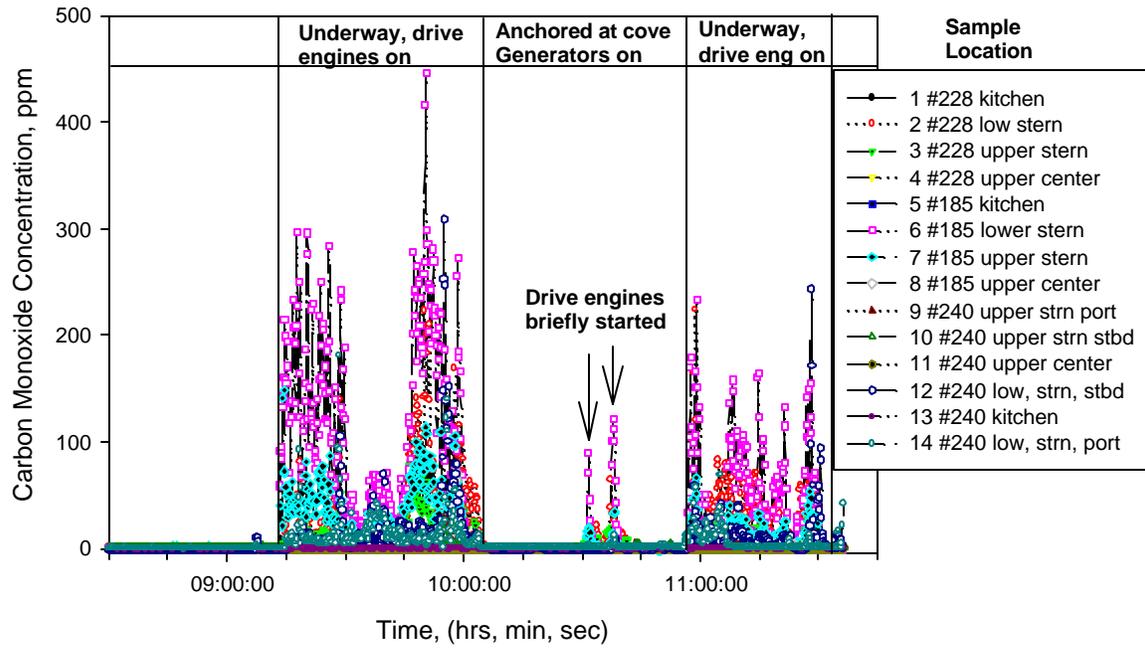
Figure 9. Comparison of CO concentrations with 3 houseboats with vertical exhaust stacks underway and 3 houseboats tied together and stationary. (Tues. aft. 10/1)

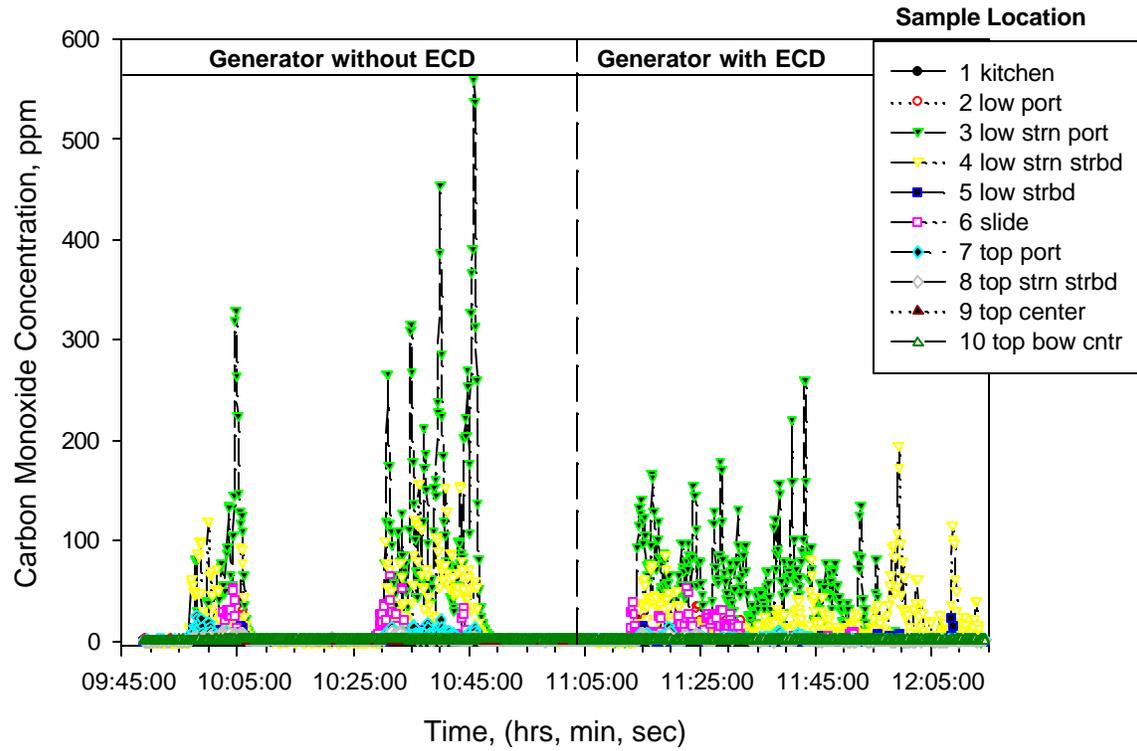
Figure 10. CO sampling on houseboat #22 showing degradation in the ECD's performance (Wed, 10/2).

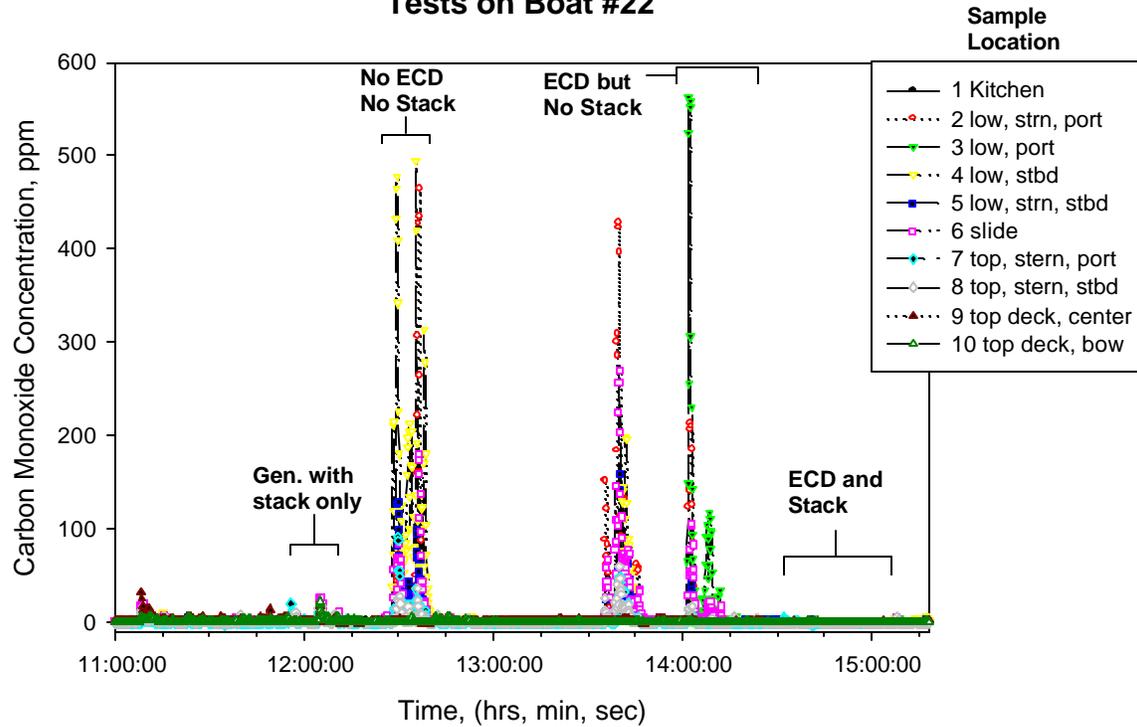
Figure 11. Comparison of CO concentrations on houseboat #340 with and without the ECD and vertical exhaust stack. (Note that the ECD reduced the CO concentration in the exhaust from approximately 1.5% to 1%). (Thurs. 10/3)

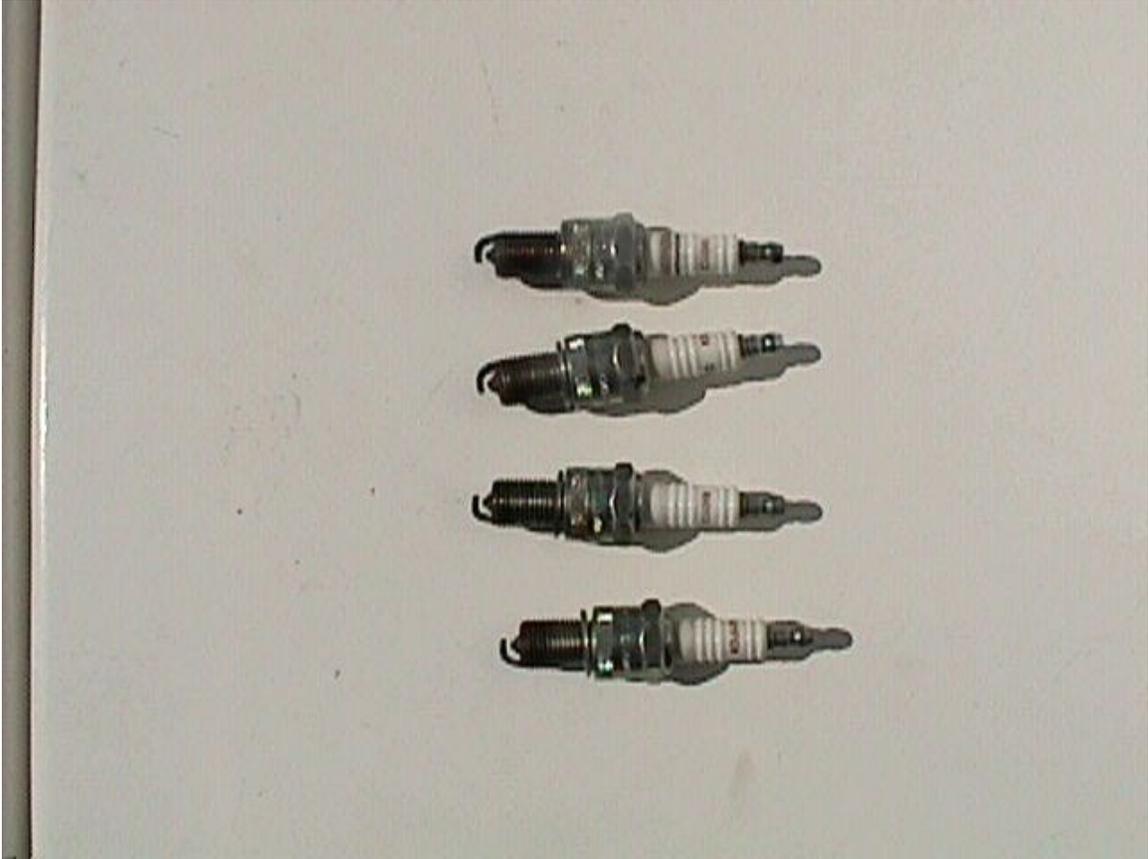
Figure 13. Badly Fouled spark plugs on houseboat generator using the ECD

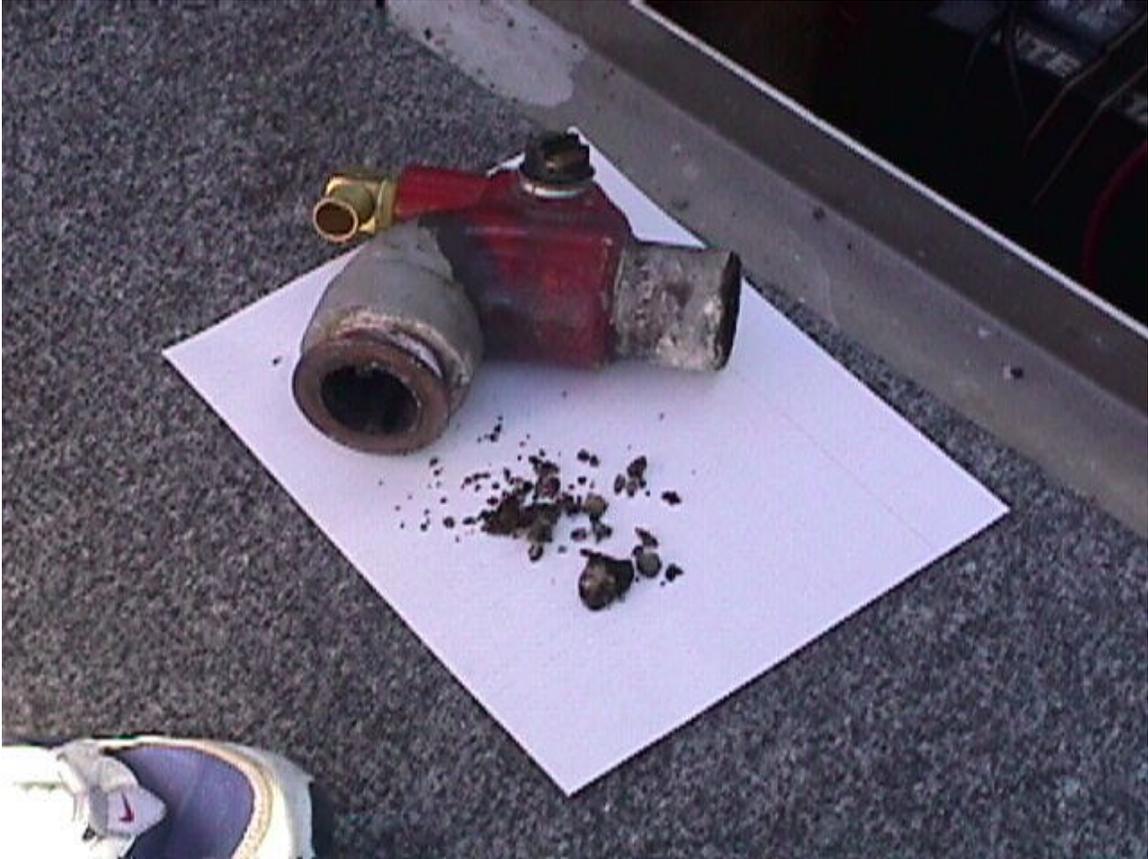
Figure 14. Carbon deposits found in the mixing elbow of the generator and ECD exhaust.
