Figure 1: Vertical Exhaust Stack on the side of the evaluated Sumerset Custom Houseboat.

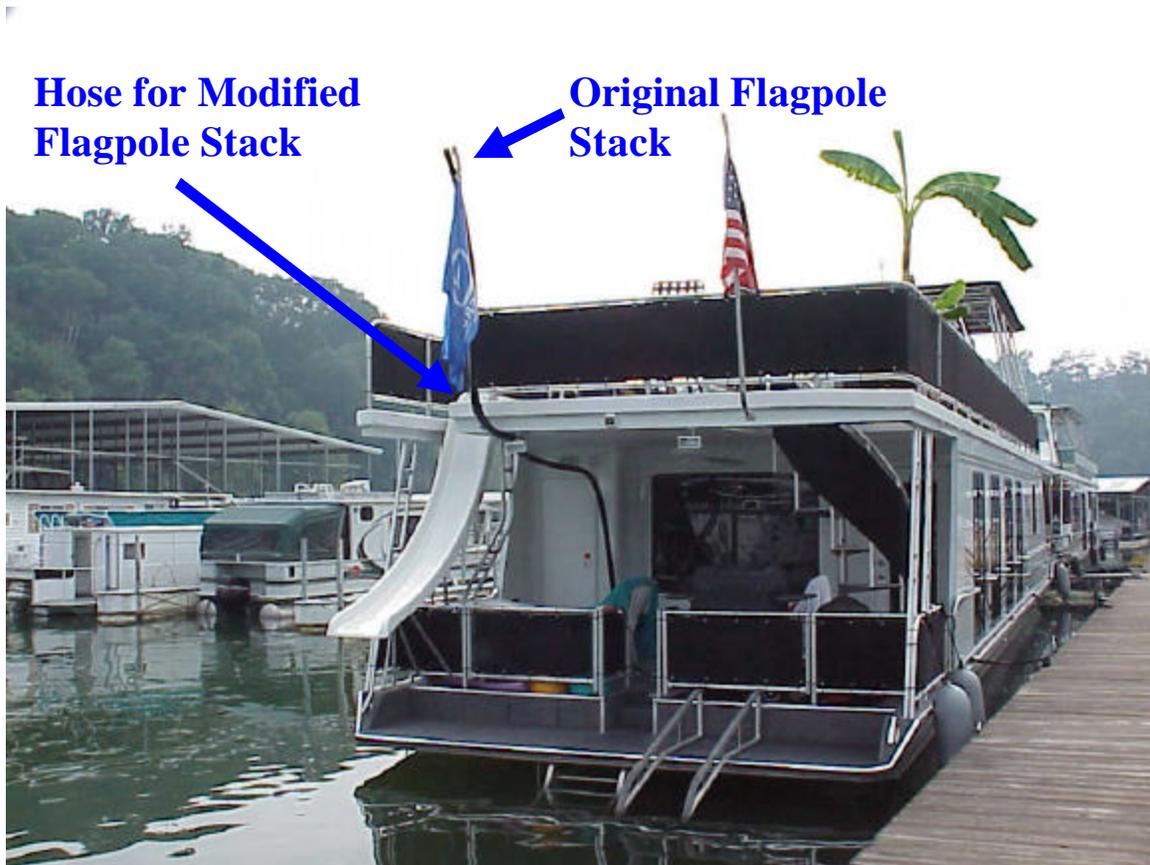
Figure 2: Modified flagpole exhaust stack on an evaluated Sumerset Custom Houseboat.

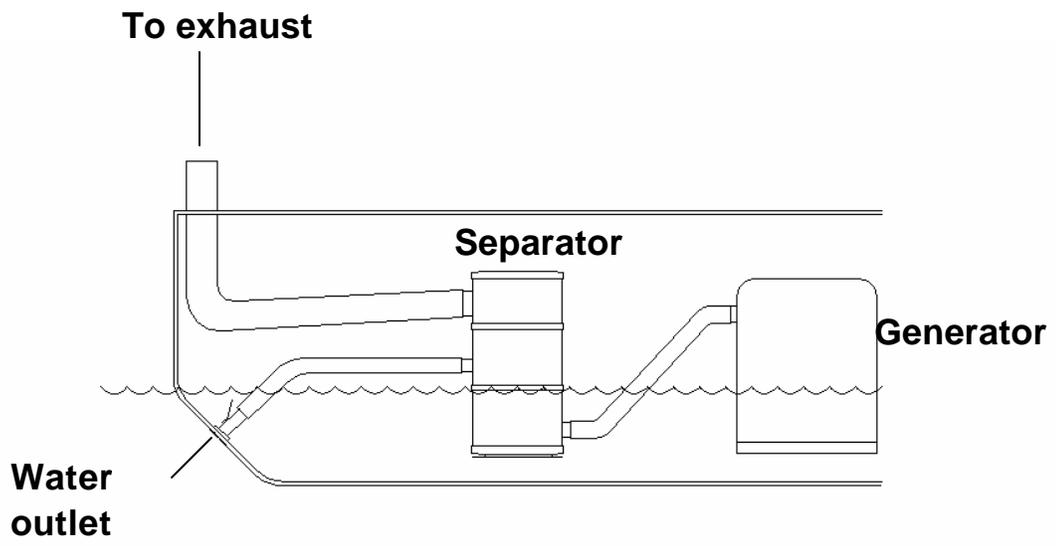
Figure 3: Simplified gas water separator configuration.

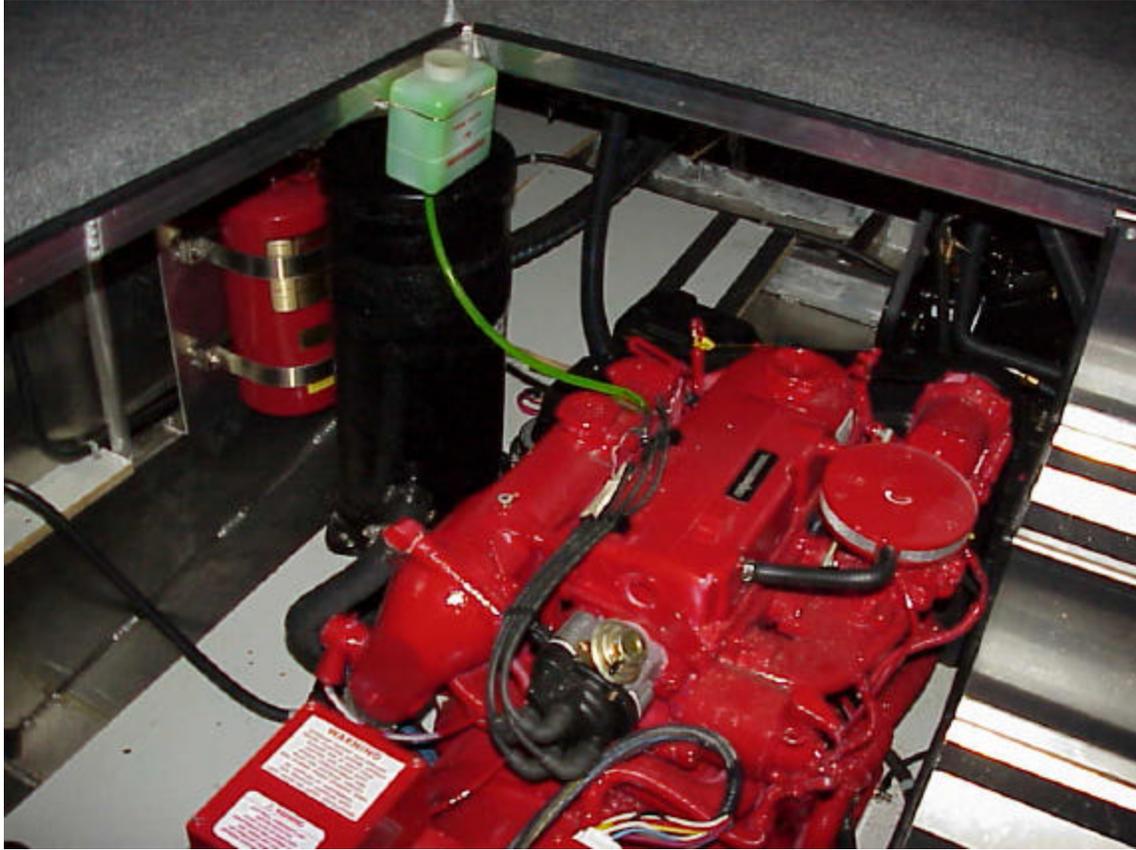
Figure 4: Combo-Sep<sup>®</sup> muffler/gas/water separator and Westerbeke 15 Kw generator.

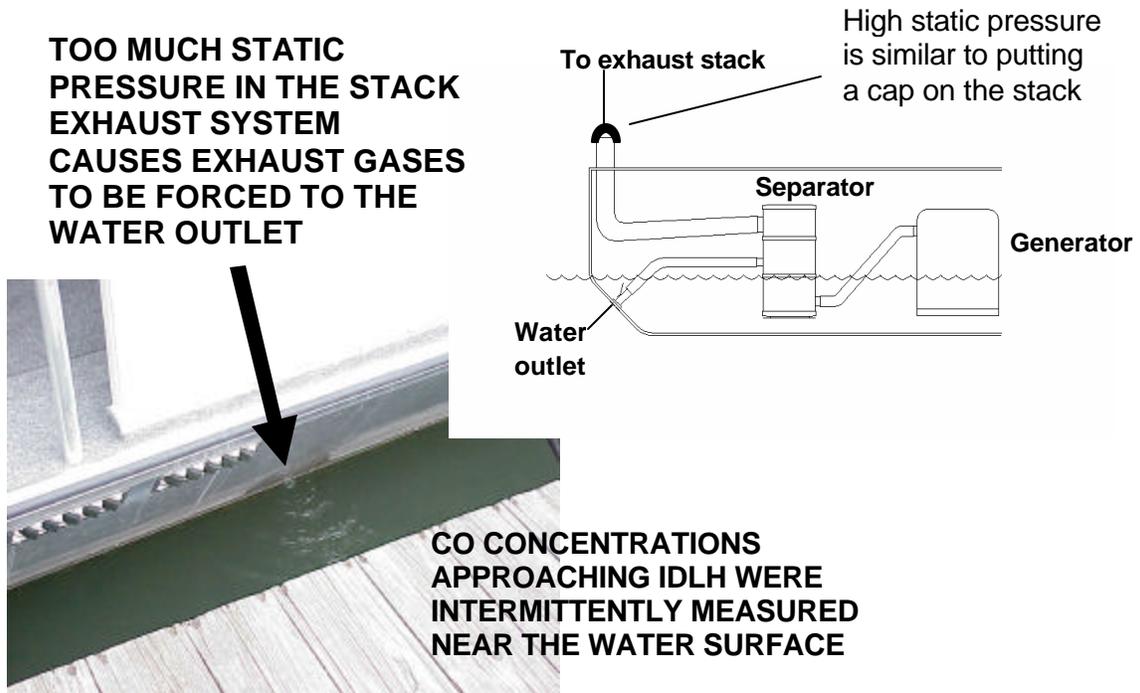
Figure 5: Visible bubbling near water outlet from high static pressure in the stack.

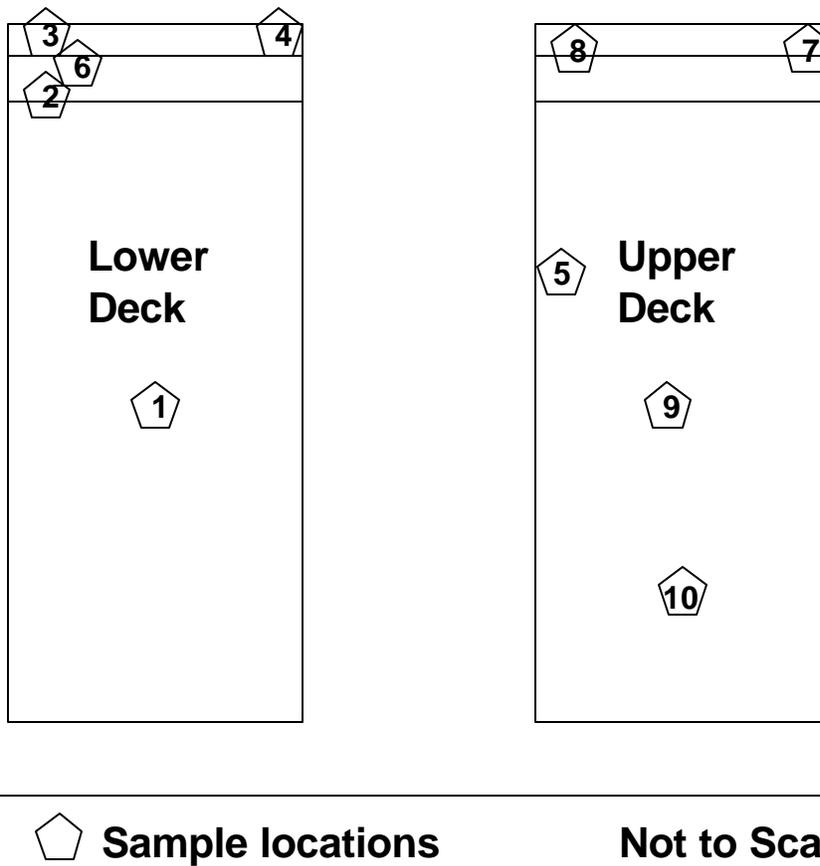
**Sampling locations for ToxiUltra CO monitors  
on the lower and upper deck of the houseboats**

Figure 6: Sampling locations on the vertical stack and flagpole stack houseboats.

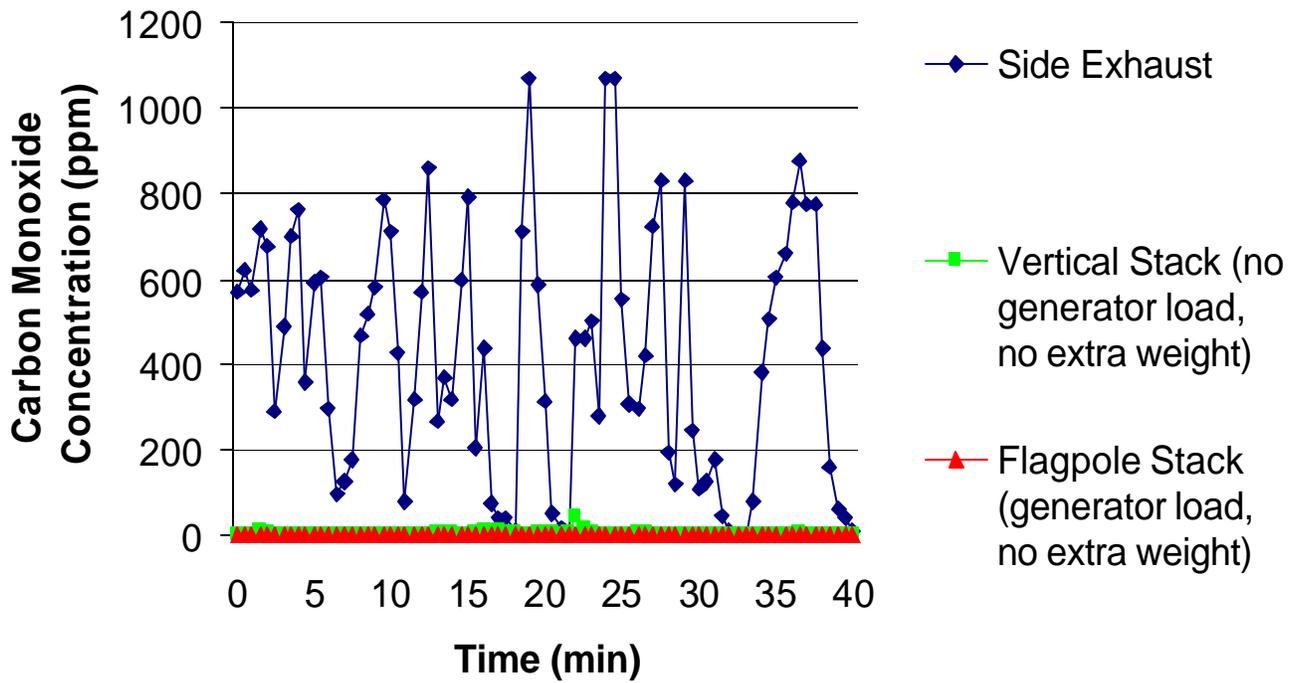
**CARBON MONOXIDE CONCENTRATIONS  
NEAR THE SWIM PLATFORM**

Figure 7: Comparison of CO concentrations on the houseboats lower deck for three different exhaust configurations.

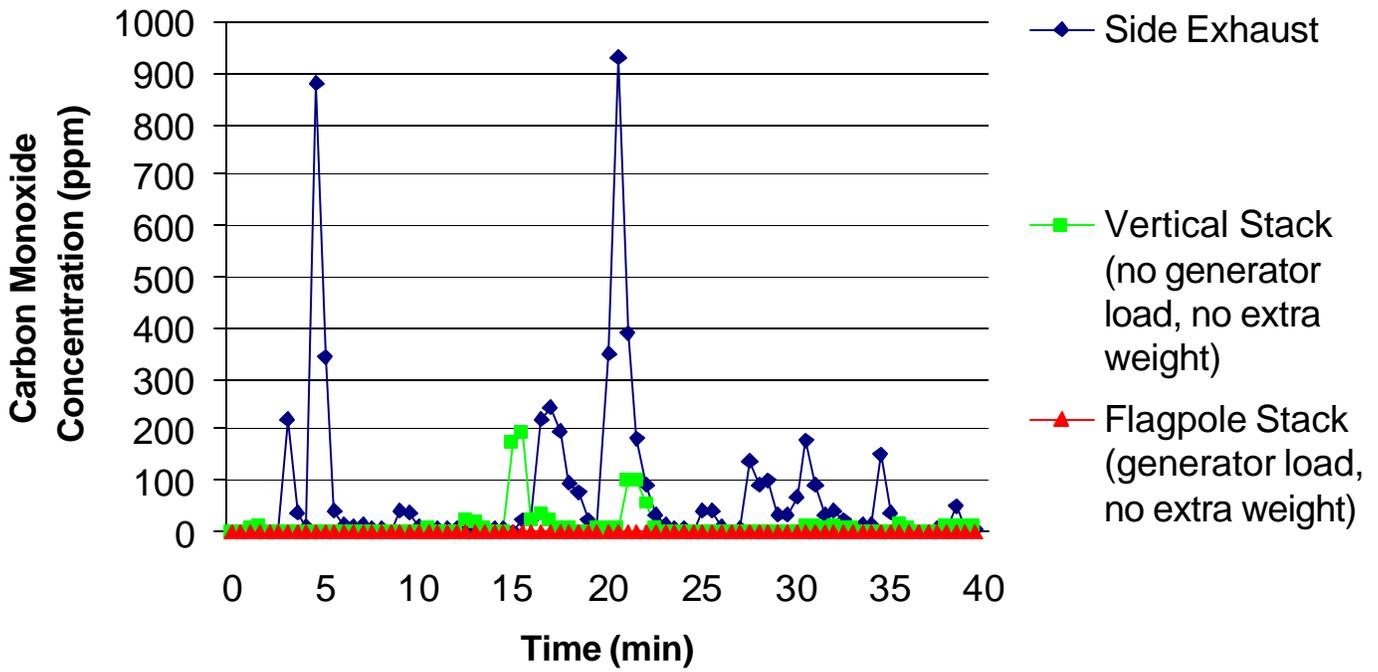
### CARBON MONOXIDE CONCENTRATIONS ON THE TOP DECK NEAR THE STACK

Figure 8: Comparison of CO concentrations on the houseboats upper deck near the stack for three different exhaust configurations.

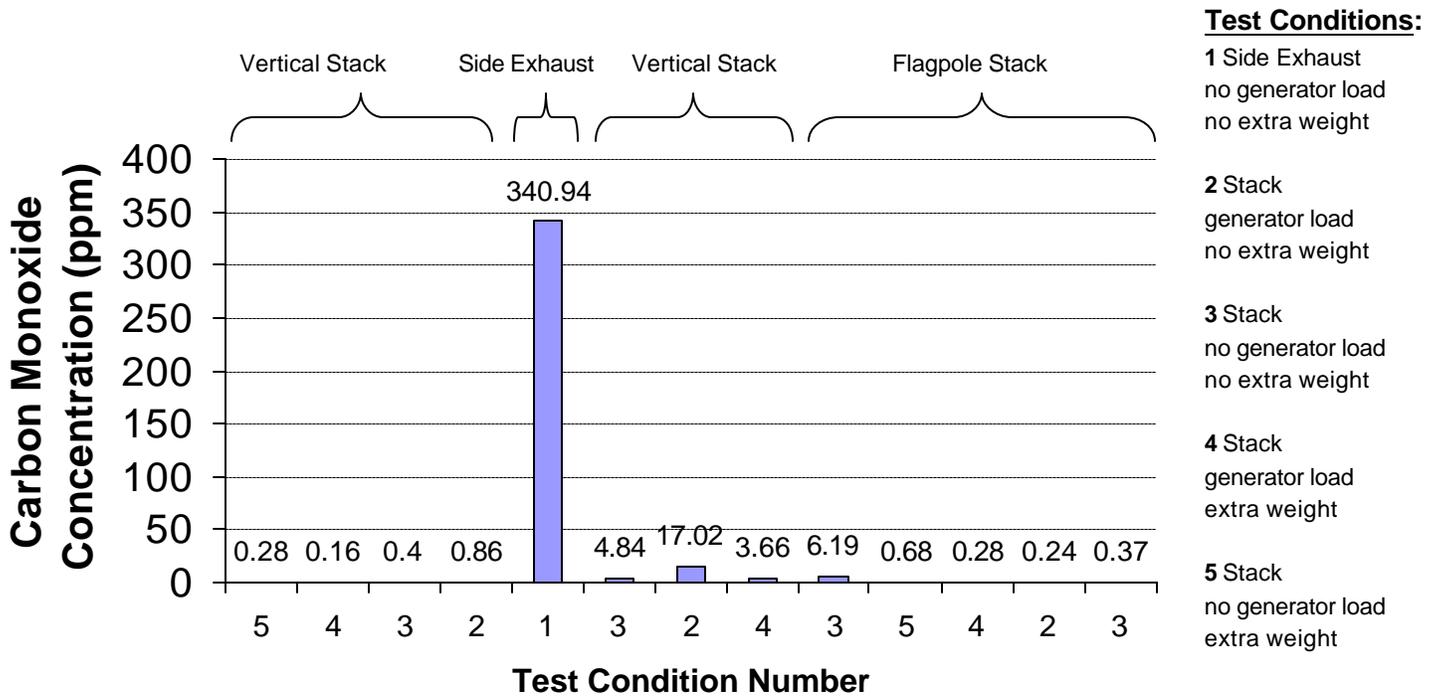
**COMPARISON OF AVERAGE CO CONCENTRATIONS ON THE STARBOARD SWIM PLATFORM FOR 5 TEST CONDITIONS**

Figure 9: Comparison of average CO concentrations on the starboard swim platform for 5 test conditions.

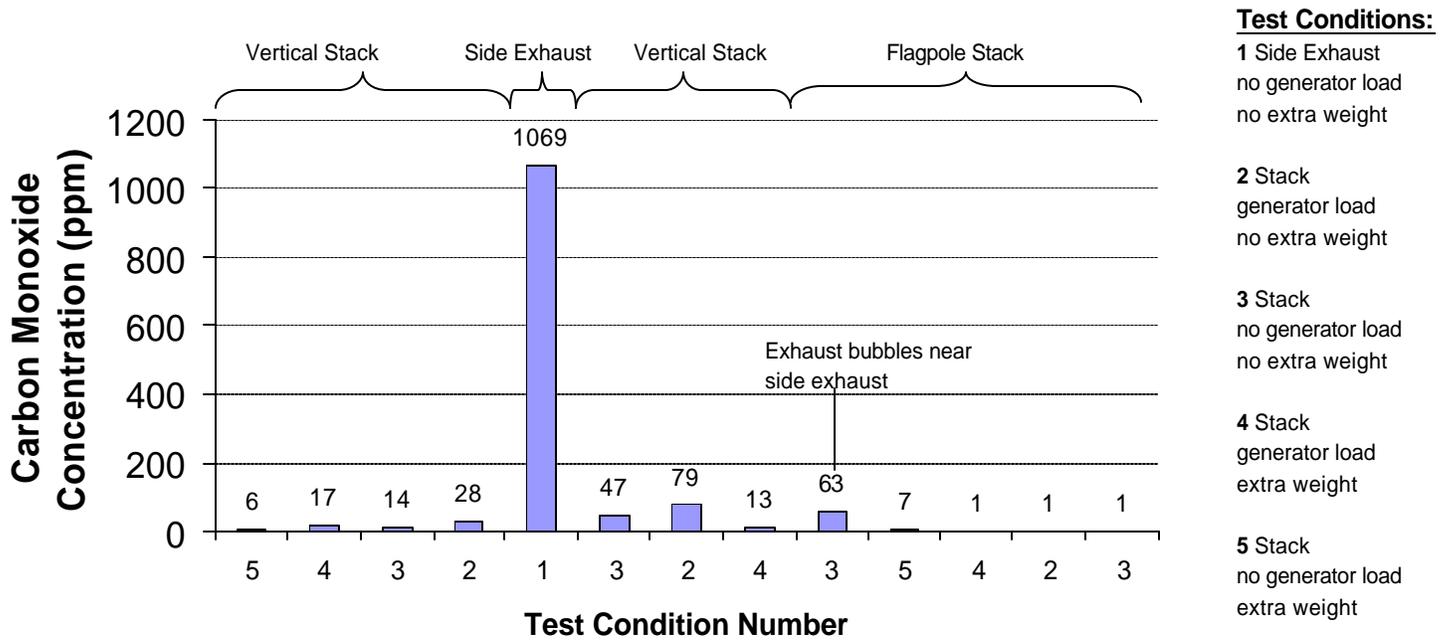
**COMPARISON OF PEAK CO CONCENTRATIONS ON THE STARBOARD SWIM PLATFORM FOR 5 TEST CONDITIONS**

Figure 10: Comparison of peak CO concentrations on the starboard swim platform for 5 test conditions.

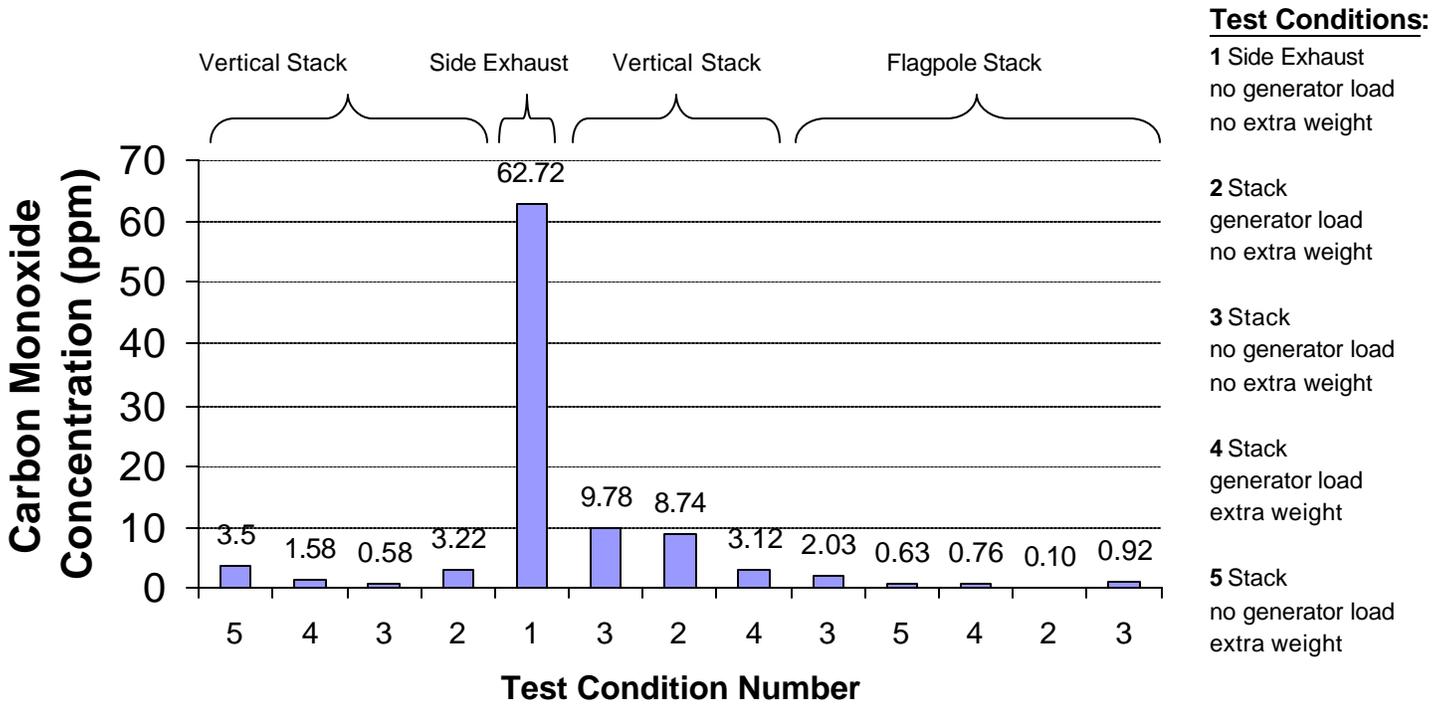
**COMPARISON OF AVERAGE CO CONCENTRATIONS ON THE TOP DECK NEAR THE STACK FOR 5 TEST CONDITIONS**

Figure 11: Comparison of average CO concentrations on the top deck near the stack for 5 test conditions.

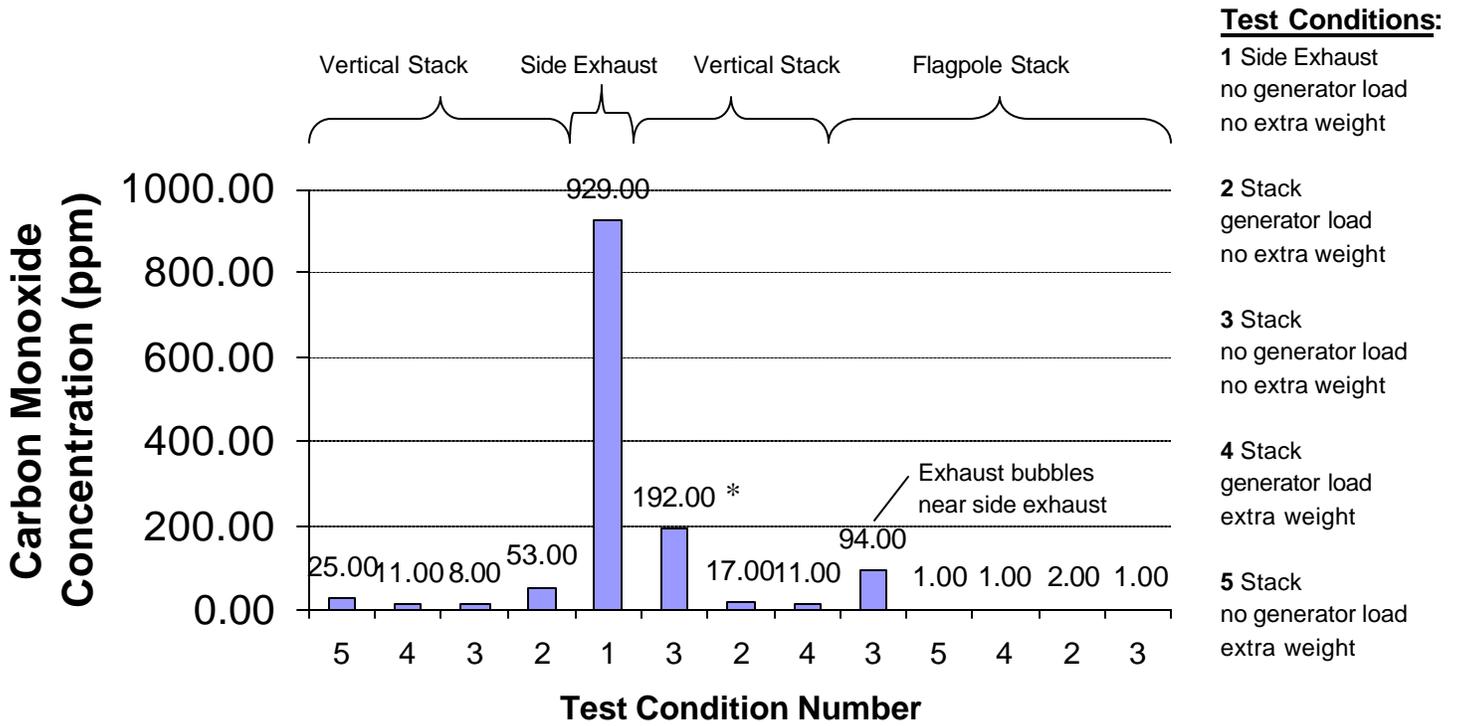
**COMPARISON OF PEAK CO CONCENTRATIONS ON THE TOP DECK  
NEAR THE STACK FOR 5 TEST CONDITIONS**
