December 18, 2000
HETA 2001-0026

On October 13, 2000, the National Institute for Occupational Safety and Health (NIOSH) received a request from the Cabinet for Health Services in the Commonwealth of Kentucky to evaluate carbon monoxide (CO) concentrations associated with the operation of houseboats on Lake Cumberland. On October 23 - 25, 2000, NIOSH investigators conducted a site visit at Lake Cumberland to investigate CO concentrations on houseboats located at the State dock, Jamestown dock, and Alligator II dock. This letter describes our evaluation methods, findings, and conclusions.

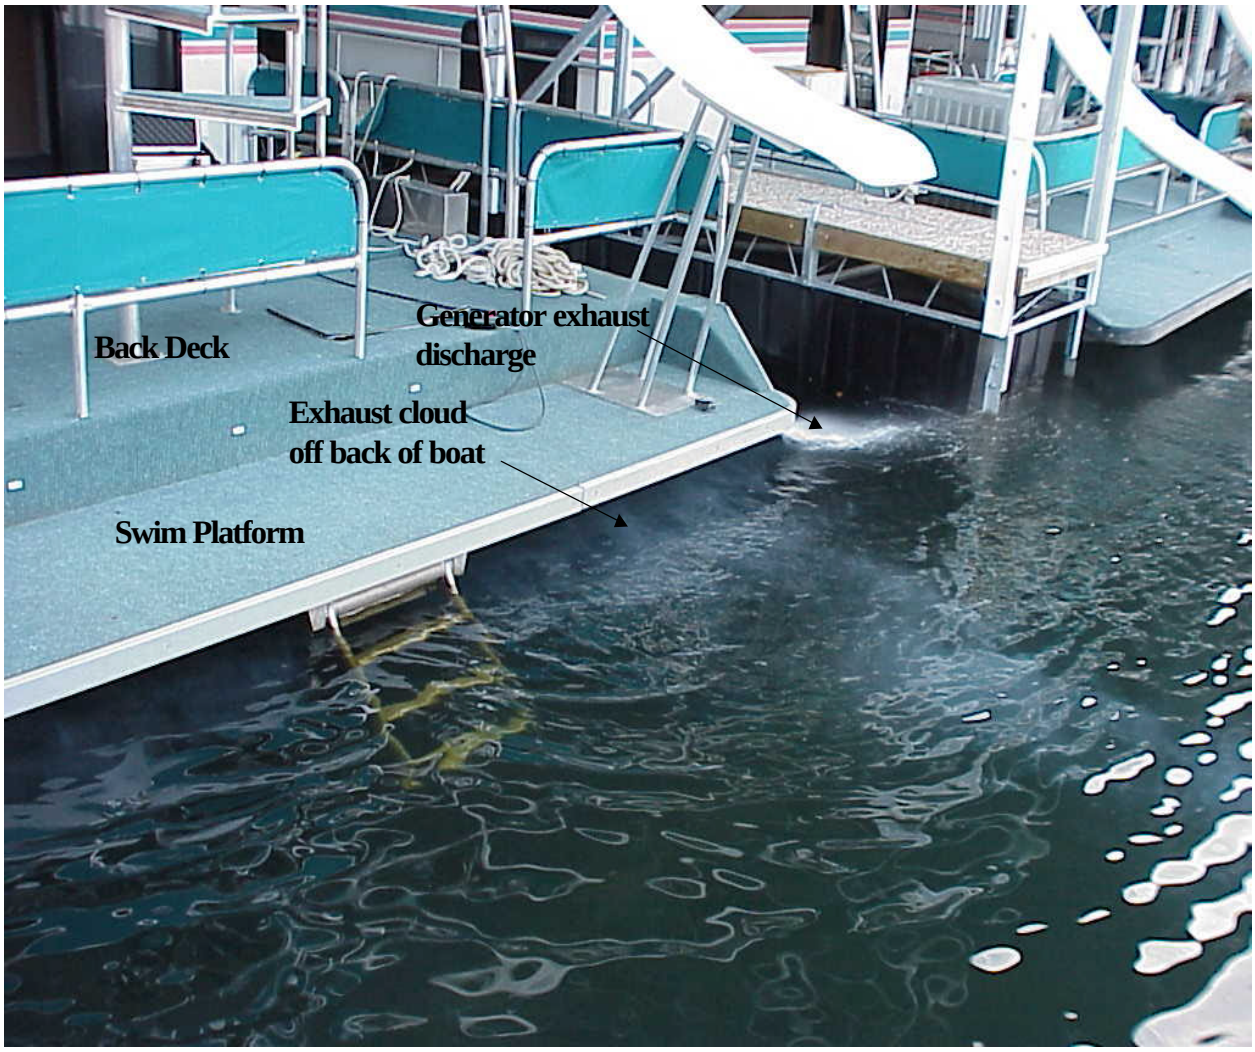
Figure 1. Swim platform and back deck of houseboat with CO sample locations.

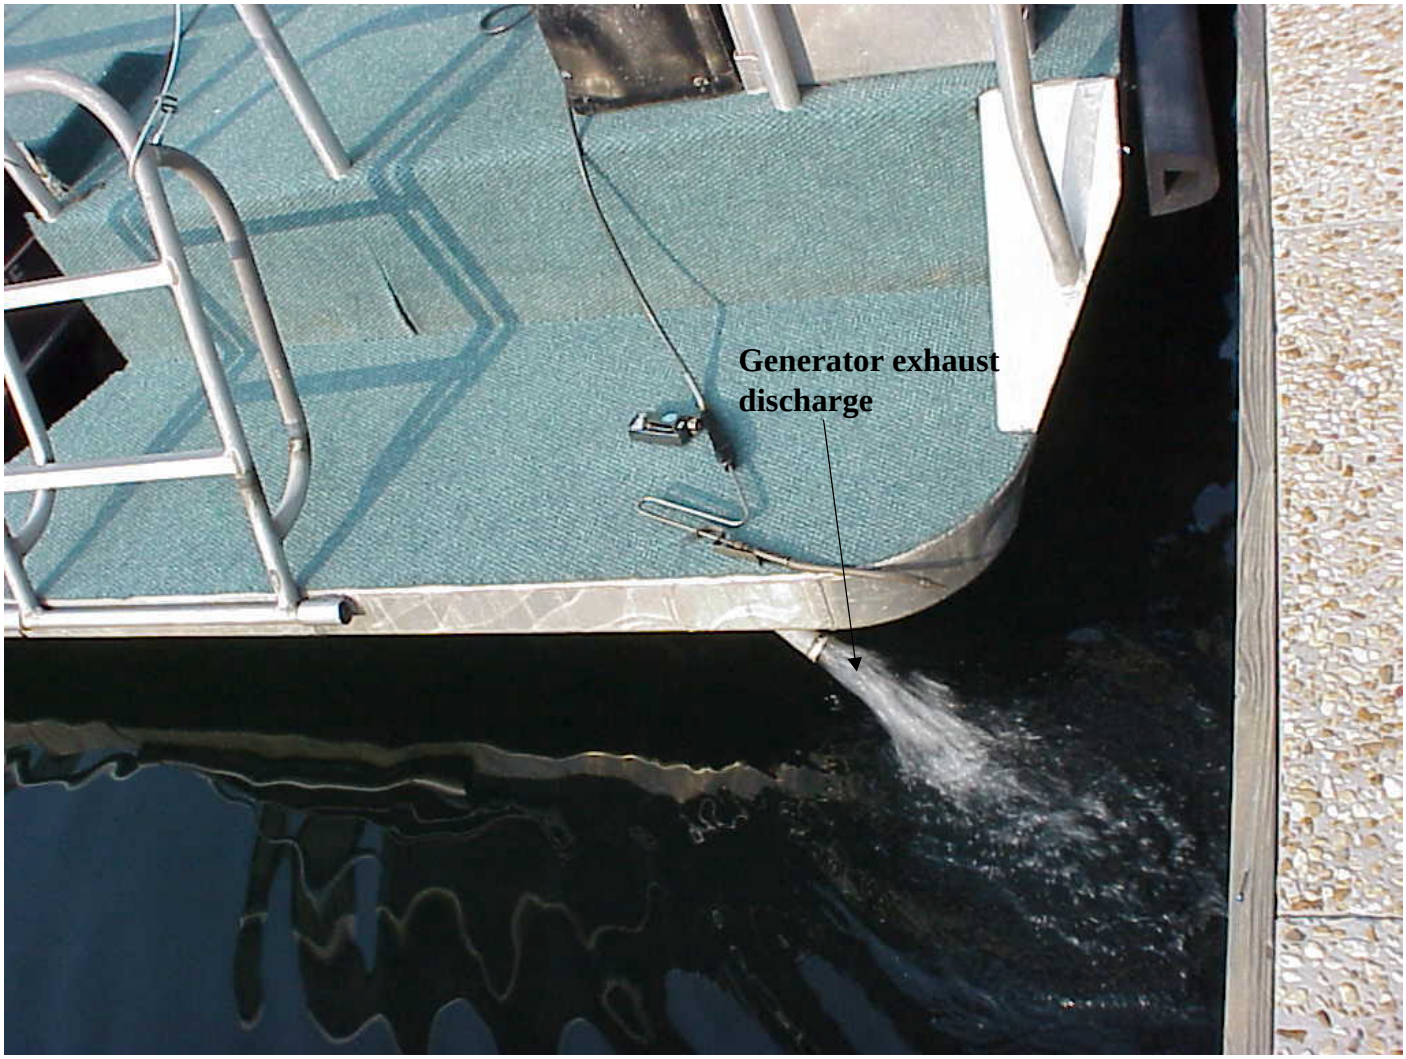
Figure 2 shows a portion of the back deck of the Navigator houseboat, and also illustrates the generator exhaust discharging out the back corner of the swim platform. An evacuated glass container measurement in this area indicated a CO concentration of 13 ppm. A similar measurement collected in an exhaust cloud off the back of the swim platform, at the water when both the generator and motors were in operation, indicated a CO concentration of 27 ppm. A third evacuated container sample collected on the swim platform with only the generator in operation did not detect CO.

* CO monitors on the right and left sides of the swim platform were placed in exhaust cloud (see Figure 2) off the back of the swim platform resulting in the reported CO peak concentrations.

Figure 2. Back View of Navigator boat and generator exhaust discharge.
