Identification of Boat-Related Carbon Monoxide (CO) Poisonings and Related Risk Factors in Glen Canyon National Recreation Area (GCNRA), Arizona/Utah

Health Hazard Evaluation Report 2000-0400-2956 & 2002-0325-2956
Glen Canyon National Recreation Area (GCNRA), Utah and Arizona

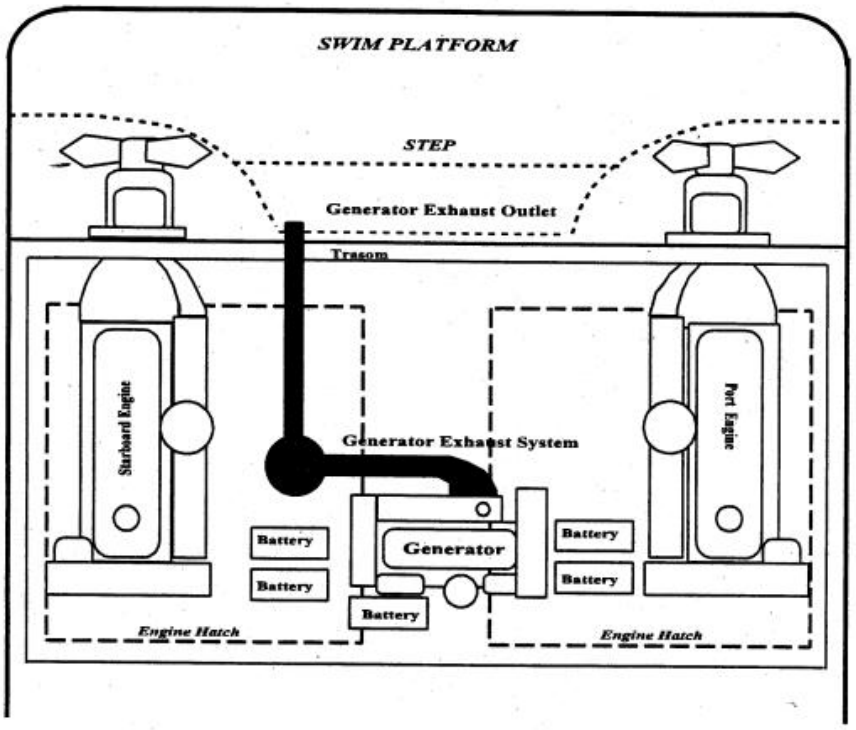
Figure 3. Overhead Diagrammatic View Illustrating Generator and Generator Exhaust Terminus Location on Houseboats of the Design Associated with Seven GCNRA Deaths

The second letter referred to two deaths in 1998 that occurred within 12 days of each other, and 10 CO-related deaths and injuries investigated by NPS occurring on boats designed as discussed above. NPS again recommended redesigning these types of boats by relocating the generator exhaust terminus and increasing air exchange in the stern cavity.

This initial air sampling investigation related to houseboats with extended rear decks and gas-powered generators with exhaust terminus exiting the boat transom under the deck (shown in pictures and diagram in Figures 1–3). The generators supply the boat with electrical power to operate on-board appliances (i.e., air-conditioner, refrigerator, lights, charging batteries, etc.

3. Manufacturers should examine options for modifying houseboat design to prevent the buildup of hazardous CO concentrations from any engine exhausting into the airspace under the deck. Design changes could include modification of the structure of the stern deck and/or sufficient pressurization of the airspace to reduce CO concentrations to safe concentrations within 1 minute of engine deactivation.

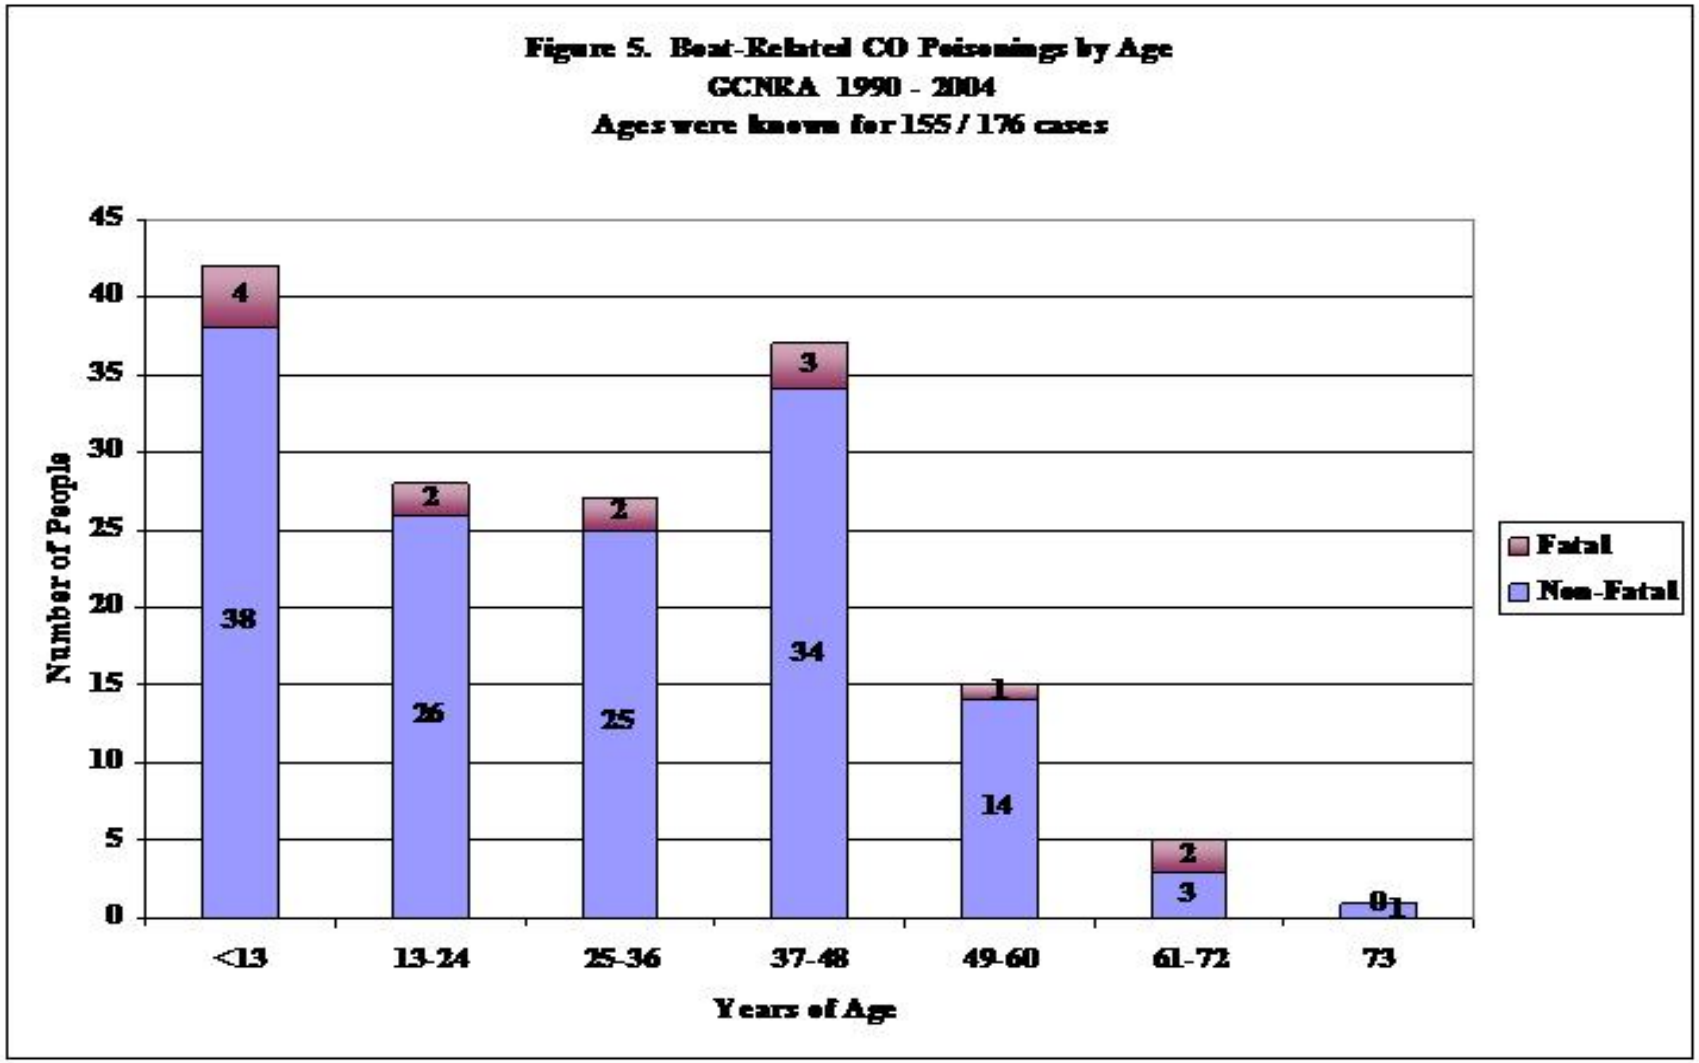
Figure 5. Boat-Related CO Poisonings by Age
GCNRA 1990 - 2004
Ages were known for 155 / 176 cases
Number of People
45
40
35
30
25
20
15
10
5
0
4
38
2
26
2
25
3
34
1
14
2
3
0
1
<13
13-24
25-36
37-48
49-60
61-72
73
Years of Age
Fatal
Non-Fatal

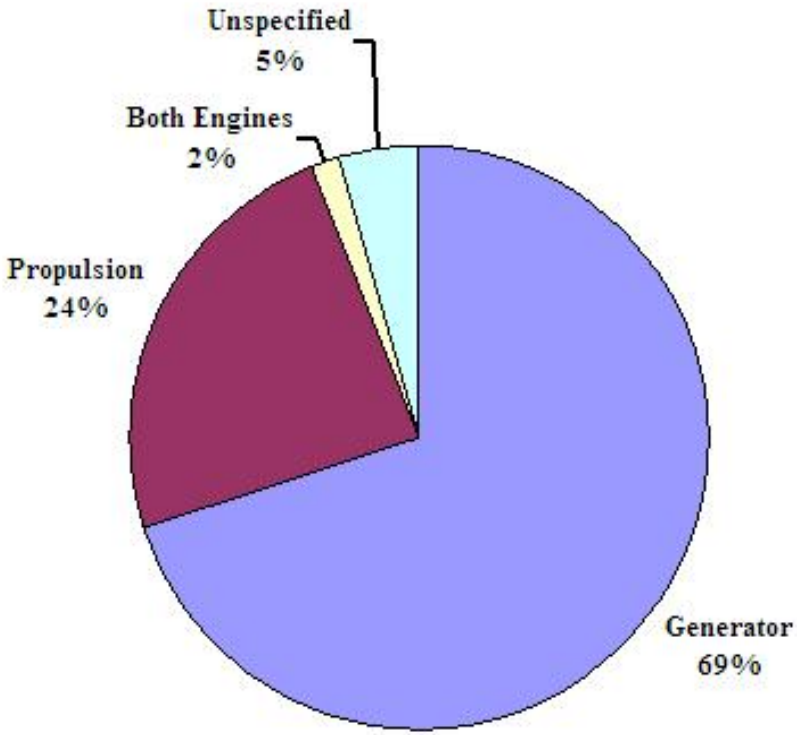
Figure 6. Boat-Related CO Poisonings by Source of CO
GCNRA 1990 - 2004
(n = 176)

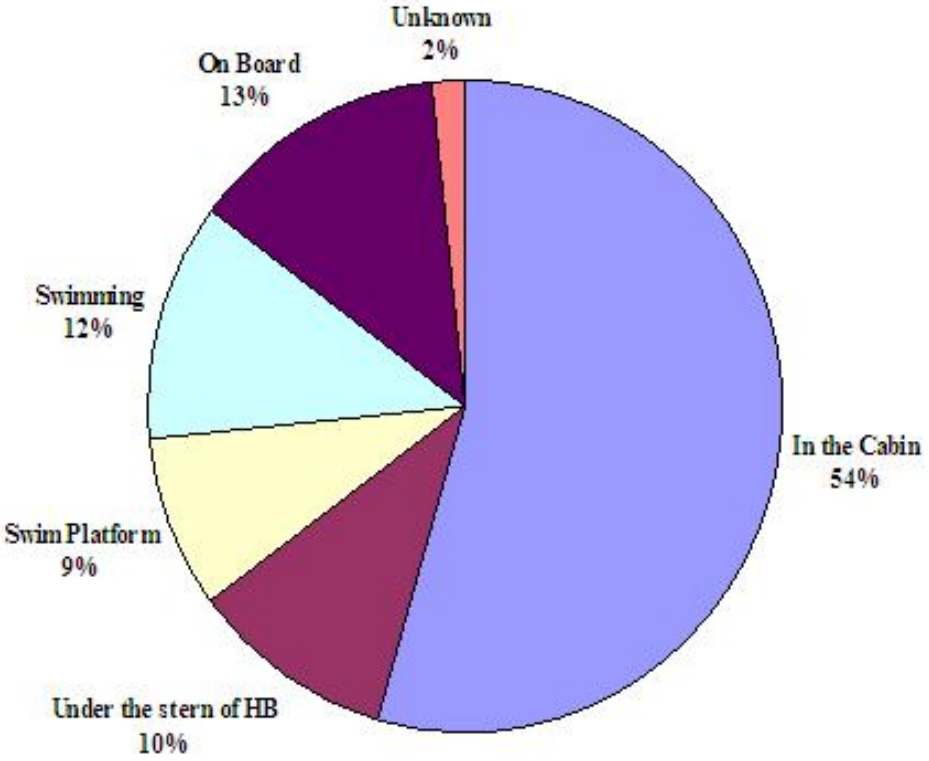
Figure 7. Boat-Related CO Poisoning by Location of Victim
GCNRA 1990 - 2004
(n = 176)

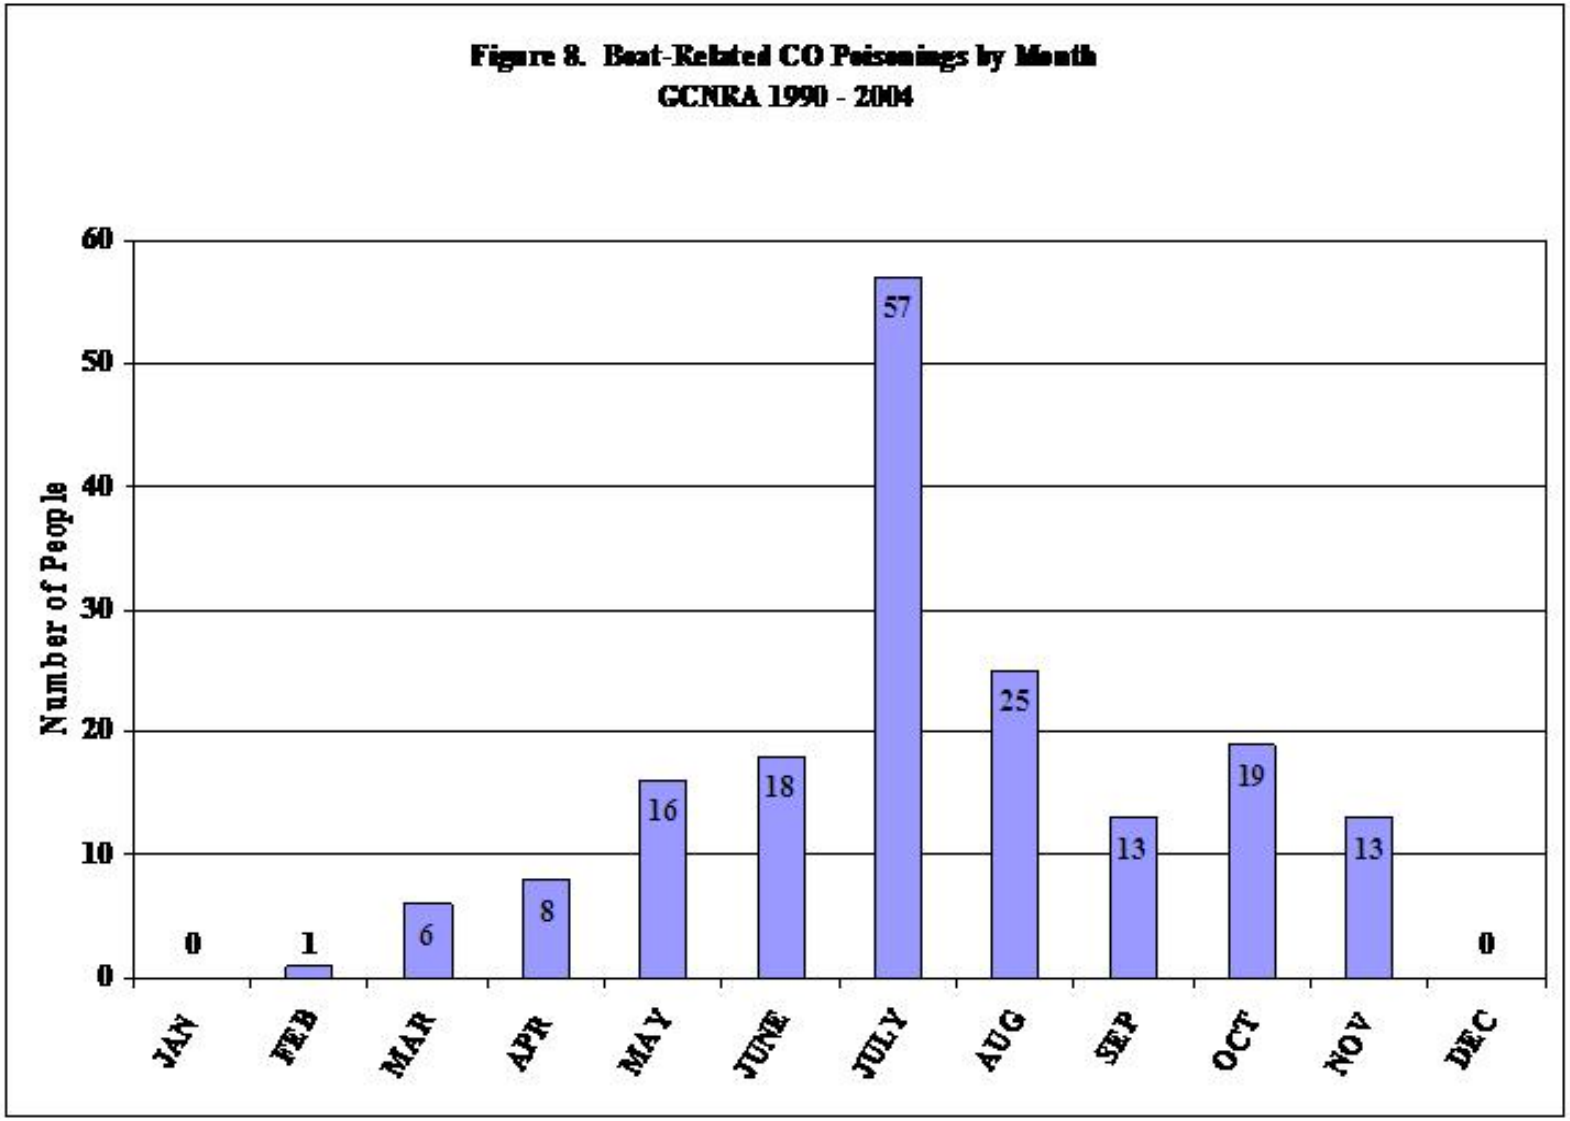
Figure 8. Boat-Related CO Poisonings by Month
GCNRA 1990 - 2004
Number of People
60
50
40
30
20
10
0
0
1
6
8
16
18
57
25
13
19
13
0
JAN
FEB
MAR
APR
MAY
JUNE
JULY
AUG
SEP
OCT
NOV
DEC
