# An Evaluation of an Engineering Control to Prevent Carbon Monoxide Poisonings of Individuals on and Around Houseboats

**Keywords:** carbon monoxide, combustion, engineering control, exhaust stack, houseboats, poisoning

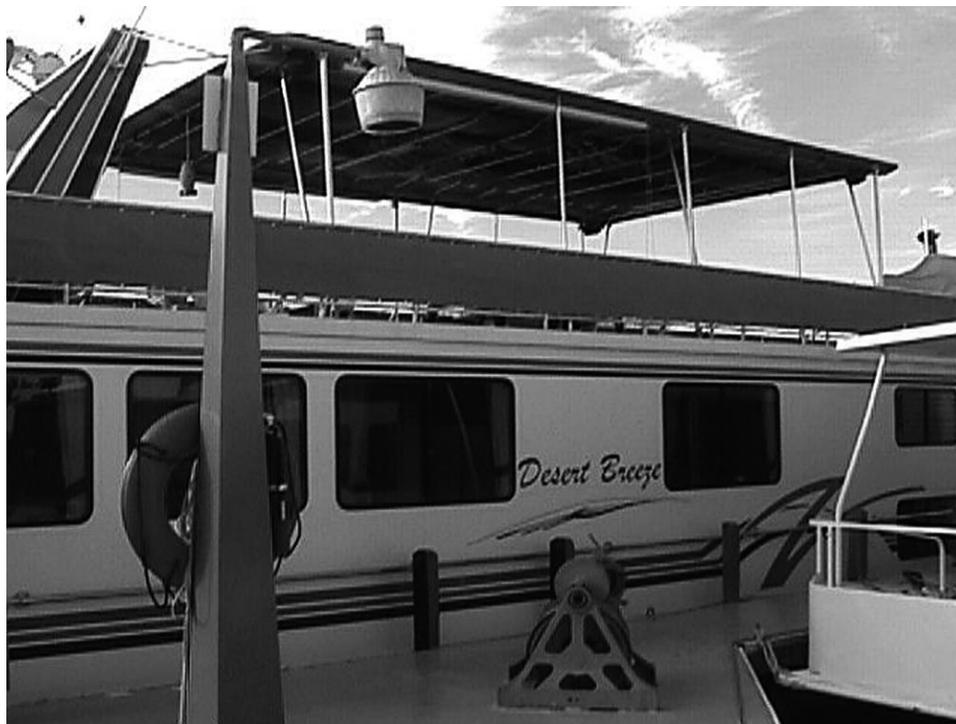
FIGURE 1. Photo of the evaluated Lakeview houseboat

Air sampling for CO, ventilation, and wind-velocity measurements were collected on a five-bedroom Lakeview houseboat, built in 1999 (Figure 1). These data were collected in an effort to evaluate the performance of an engineering control that had been retrofitted on to a gasoline-powered generator on the houseboat. A description of the houseboat and engineering control follow.

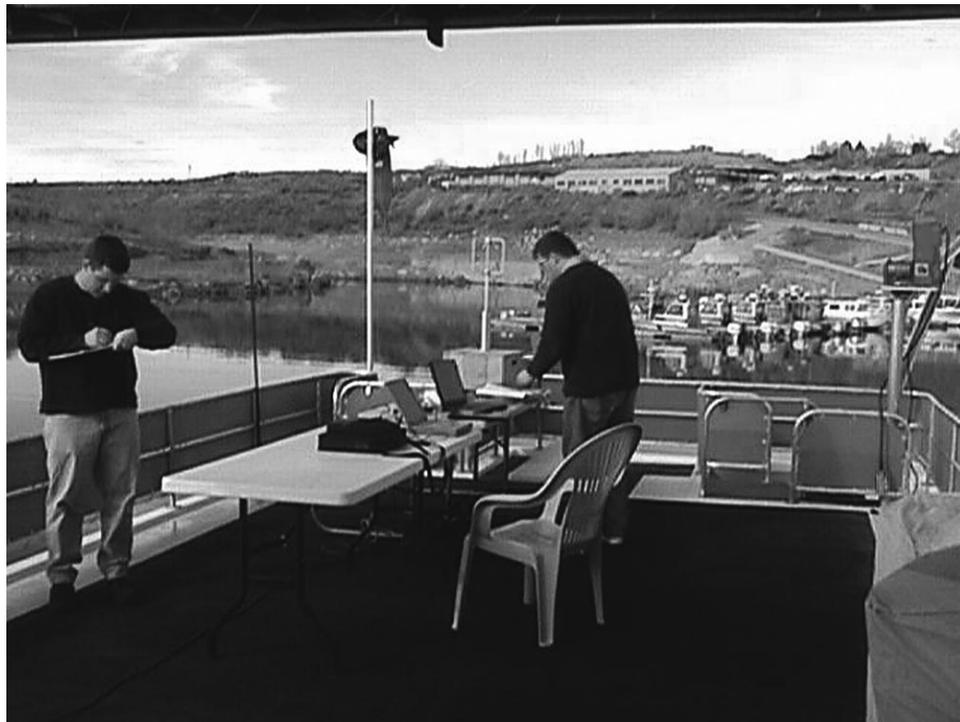
FIGURE 2. Photo of the generator exhaust stack near the upper deck of the houseboat

The original exhaust system was modified to reroute the generator exhaust approximately 9 ft above the upper deck of the houseboat and nearly 20 ft above the water level to prevent the buildup of hazardous concentrations of CO near the boat’s lower rear deck. An 18-ft, schedule-40 aluminum pipe, having a 2-inch outside diameter and 1.5-inch inside diameter, was used for the stack (Figure 2). NIOSH researchers were informed that this relatively thick and heavy pipe was the only suitable conduit available in Page, Ariz., at the time of construction. To allow the pipe to pass from beneath the lower swim deck to 9 ft above the upper deck, a hole had been made in the rear corner of the transom through which the 2-inch pipe passed. A Gensep<sup>®</sup> water/exhaust separator (Centek Industries, Thomasville, Ga.) was installed between the muffler and the stack to separate the exhaust gases from the water by using the force of gravity. This separator is commonly used on some houseboats and other types of boats to further reduce noise related to water surges from the lift muffler. A diagram of this system is shown in Figure 3.

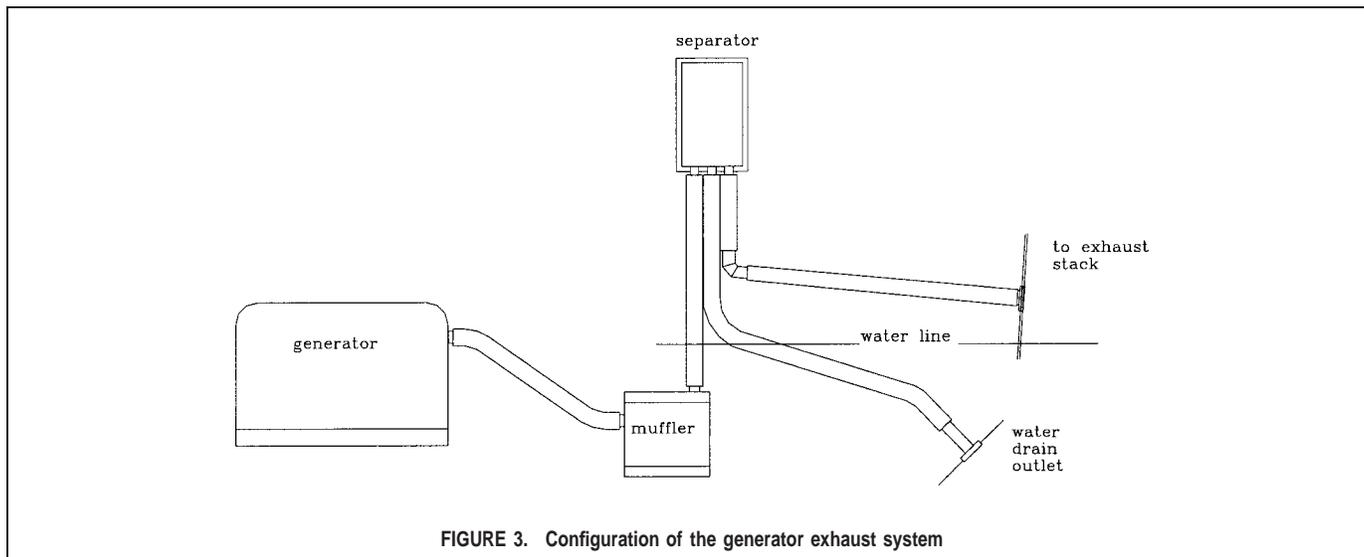
FIGURE 3. Configuration of the generator exhaust system

To function properly, the exhaust stack must be correctly sized based on the exhaust gas volume, water flow rate, and the maximum pressure differential permitted by the manufacturer. Also important, the separator must release the water less than 8 inches below the water line to reduce back pressure, which could force some water up the stack. The evaluated system, designed and installed by Lake-Time Houseboats (Page, Ariz.) and Larry’s Marine (Page, Ariz.), released generator effluent from the stack at a velocity of approximately 1100 ft/min and a temperature of approximately 58°F.

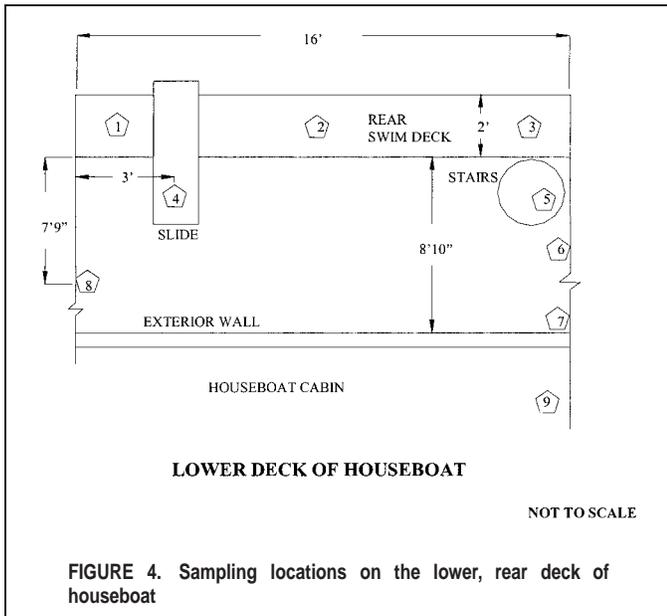
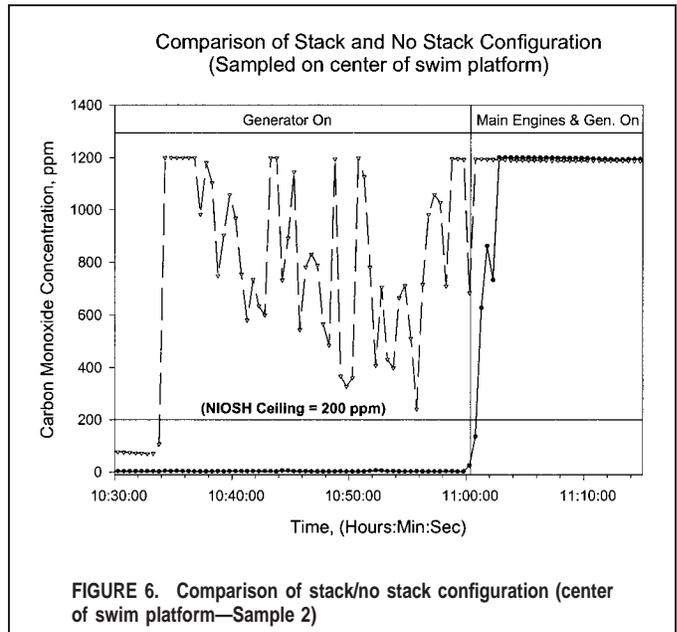
Sampling locations on the lower and upper decks of the houseboat are designated by pentagons in Figures 4 and 5. To provide

representative CO area air samples, the monitors were placed in likely passenger locations on the upper and lower decks of the houseboat, where people could be during generator operation. Because passengers commonly enter and exit the water via the rear swim platform of the boat, three monitors were evenly spaced across this structure.

The CO monitor placed at the center of the rear swim platform (Figure 4, Sample 2) indicated an average CO concentration of 606.6 ppm and a peak greater than 1200 ppm when the generator exhausted under the rear swim deck. This same sample indicated an average of 2.9 ppm and a peak of 13.0 ppm when the generator was operating and the stack connected. This is an average reduction of approximately 99.5%. These results are shown in Figure 6.

The CO monitor placed on the upper deck near the slide (Figure 5, Sample 10) indicated an average CO concentration of 13.8 ppm and a peak of 93.0 ppm when the generator exhausted under the rear deck. This same sample indicated an average of 2.2 ppm and a peak of 7.0 ppm with the generator operating and the stack

<sup>A</sup> Sample locations shown in Figure 4.

<sup>A</sup>Sample locations shown in Figure 5.

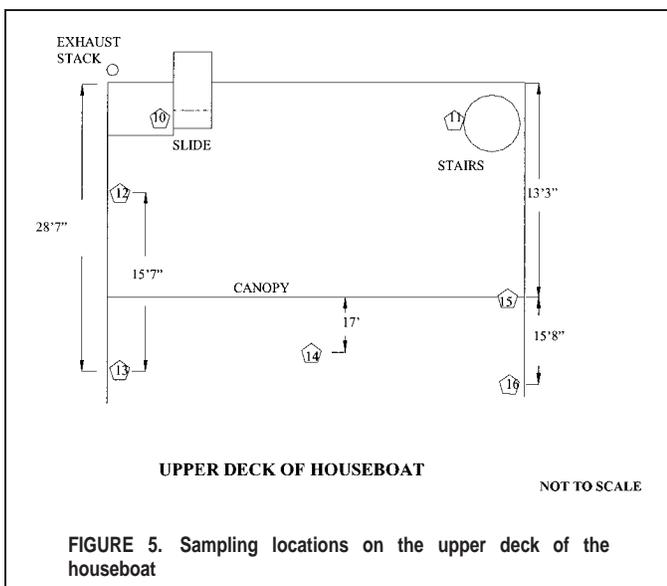
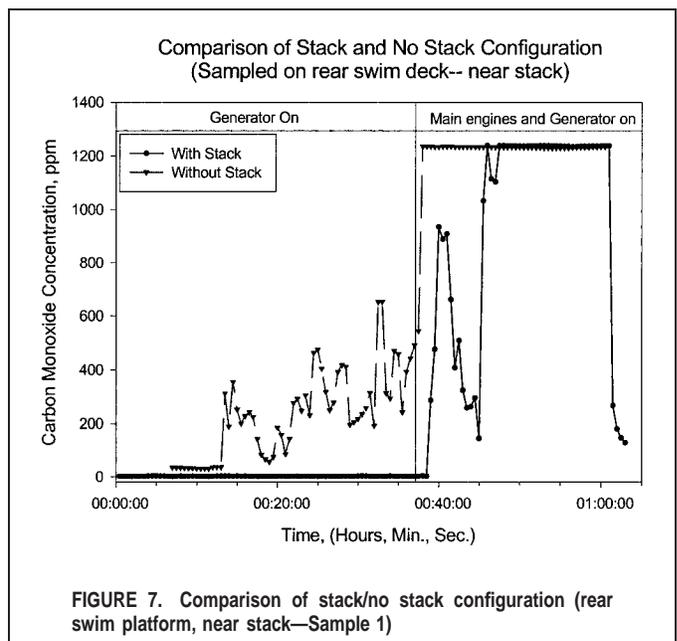
Real-time monitoring results for CO concentrations at various locations on the houseboat are presented in Figures 6 through 10. Figures 6 through 8 provide a comparison of CO concentrations on the houseboat when the generator exhausted through the stack to when it exhausted under the rear swim deck. Figures 9 and 10 provide a comparison of CO concentrations at multiple locations on the houseboat simultaneously, with and without the stack.

Similarly, the monitor located near the wall that separated the rear deck from the cabin (Figure 4, Sample 7) indicated an average

CO concentration of 62.6 ppm and a peak of more than 281 ppm when the generator exhausted under the rear deck. This same sample (Figure 4, Sample 7) indicated an average of 5.4 ppm and a peak of 15.0 ppm while the generator was operating and the stack connected. This is an average reduction of approximately 91.4%. Figure 7 shows results of the monitor located on the rear swim platform near the stack (Figure 4, Sample 3). In this case as in most others, the CO concentrations were dramatically different: peak concentrations were near baseline when the generator exhausted through the stack versus the highest peak concentrations of between 400 and 1000 ppm when it exhausted under the rear deck. In virtually all samples evaluated on the lower rear deck, concentrations were dramatically worse when the drive engines were started, but the houseboat remained stationary. This condition is illustrated on the right side of each graph (Figures 6, 7). On the rear lower deck, concentrations rapidly exceeded the NIOSH IDLH

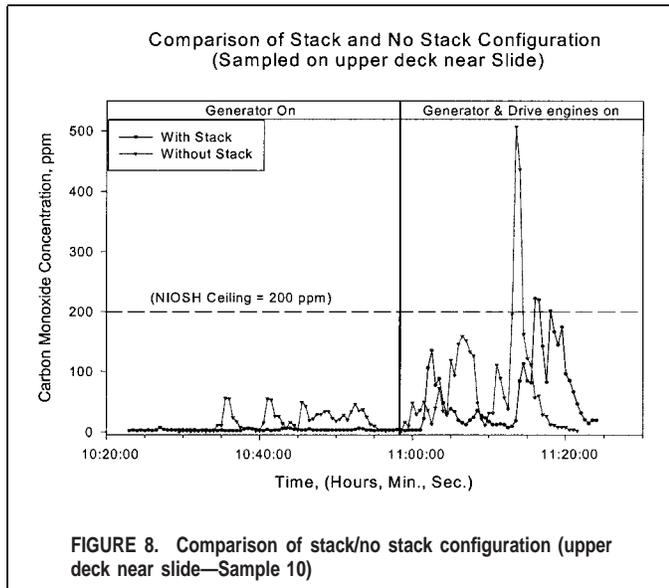
**FIGURE 8.** Comparison of stack/no stack configuration (upper deck near slide—Sample 10)

connected, an average reduction of approximately 83.9%. These results are presented in Figure 8. The monitor located on the upper deck near the stairs (Figure 5, Sample 11) indicated an average CO concentration of 14.4 ppm and a peak of 72.0 ppm when the generator exhausted under the lower rear deck. This same sample indicated an average of 1.8 ppm and a peak of 16.0 ppm with the generator operating and the stack connected, an average reduction of approximately 87.5%. Although the upper deck was closer to the stack exhaust than the lower deck, interestingly, the CO concentrations were still lower on the upper deck when the generator exhausted through the stack than when it did not. The results of other samples collected on the upper deck are shown in Table II.

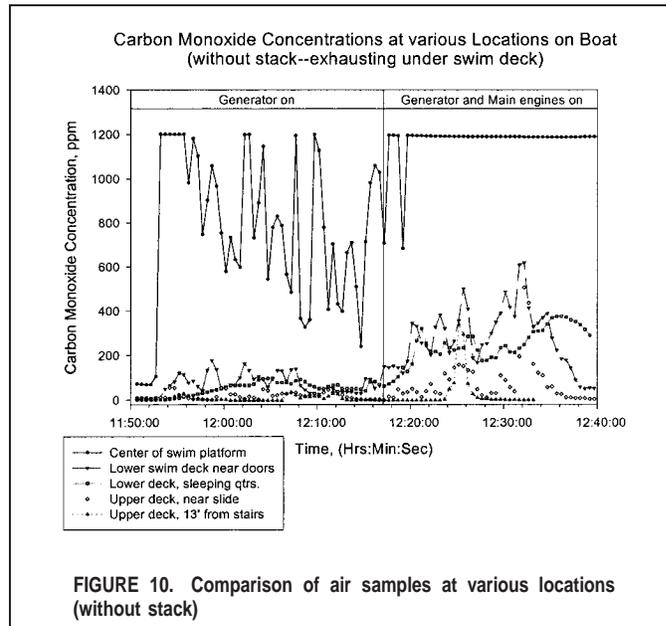
**FIGURE 10.** Comparison of air samples at various locations (without stack)

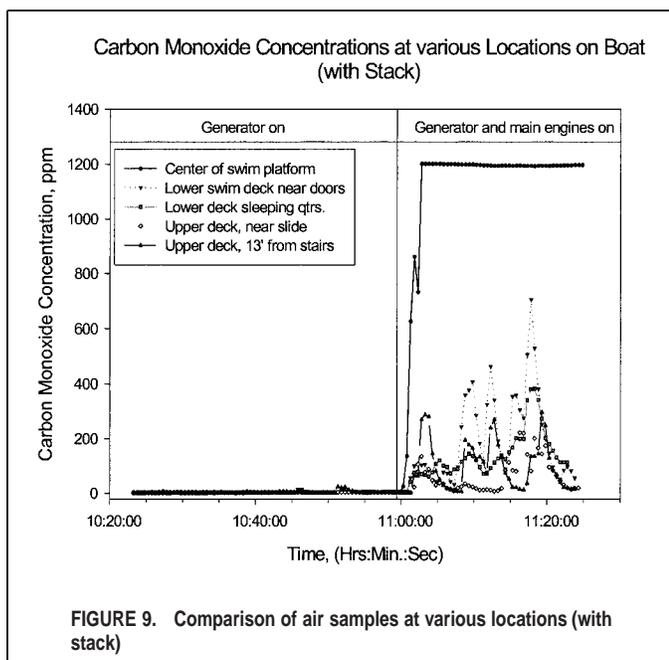
**FIGURE 9.** Comparison of air samples at various locations (with stack)

Figure 9 provides data that illustrates how CO concentrations at various locations changed with time as the generator (exhausting through the stack) and later both the generator (exhausting through the stack) and drive engines (exhausting through the propeller shafts) were operated. In contrast, Figure 10 provides data showing how CO concentrations at various locations changed over time as the generator (exhausting under the lower rear deck) and later both the generator (exhausting under the lower rear deck) and drive engines (exhausting through the propeller shafts) were operated. These two graphs clearly show that the most hazardous location was the rear swim platform near the water; however, Figure 9 shows that the stack dramatically reduced CO concentrations in that area when only the generator was operating.
